NRL Report 5920

Fracture Analysis Diagram Procedures for the Fracture-Safe Engineering Design of Steel Structures

W. S. PELLINI AND P. P. PUZAK
Metallurgy Division

March 15, 1963

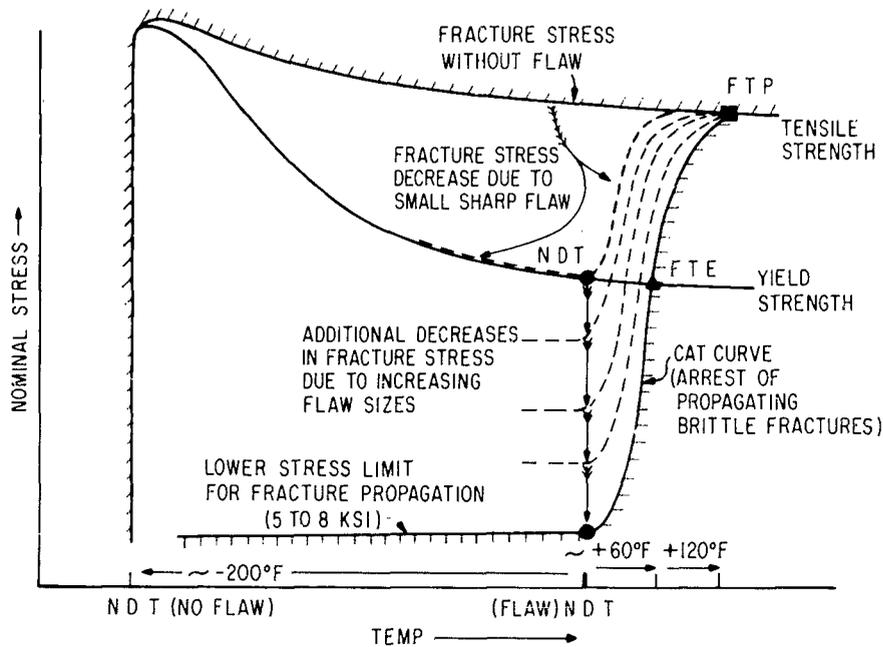
Fig. 1 — Transition temperature features of steels

The significance of the NDT temperature may be brought out by discussion of the general effects of temperature on the fracture stress transition of steels (Fig. 1). A flaw-free steel is illustrated to develop a gradually increasing tensile strength (T.S.) and yield strength (Y.S.) with decreasing temperature; the increase in yield strength is greater than that of the tensile strength, resulting in coincidence at some very low temperature. At the temperature of coincidence, tensile ductility as measured by elongation or reduction of area (plastic flow) is decreased to essentially zero or nil value. This temperature may be considered as the NDT temperature in the absence of a flaw. If a small, sharp flaw is placed in the test specimen, such as a plate, a decreased level of fracture stress is obtained in the transition range as indicated by the dashed curve labeled "fracture stress decrease due to small, sharp flaw." The highest temperature at which the decreasing fracture stress for fracture initiation due to the small flaw becomes contiguous with the yield strength curve of the steel is defined as the nil ductility transition (NDT) temperature. Below the NDT temperature the fracture stress curve for the small flaw follows the course of the yield strength curve, as indicated by the continuation of the dashed curve to lower temperatures. The arrows pointing down from the NDT point indicate that increases in the flaw size result in progressive lowering of the fracture stress curve to lower levels of nominal stress. As an approximation, the fracture stress is inversely proportional to the square root of the flaw size. The resulting family of fracture stress curves are characterized by a common temperature effect, involving a marked increase in the stress required for fracture as the temperature is increased above the NDT temperature.

A curve noted as CAT (crack arrest temperature) is drawn to represent the fracture *arrest* relationship between stress and temperature. The CAT curve represents the temperature of arrest of a propagating brittle fracture for various levels of applied nominal

stress. The crack arrest temperature for a stress level equal to the yield strength has been defined by the authors in previous reports as the "fracture transition elastic" (FTE) temperature and marks the highest temperature of fracture propagation for purely elastic loads. Similarly, the "fracture transition plastic" (FTP) temperature has been defined as the temperature above which fractures are entirely shear, *i.e.*, show no center regions of cleavage fracture, and the stress required for fracture approximates the tensile strength of the steel. The lower shelf in the range of 5 to 8 ksi, labeled as the "lower stress limit for fracture propagation" represents the stress level, below which fracture propagation is not possible because the minimum, small amount of elastic strain energy release required for continued propagation of brittle fractures is not attained.

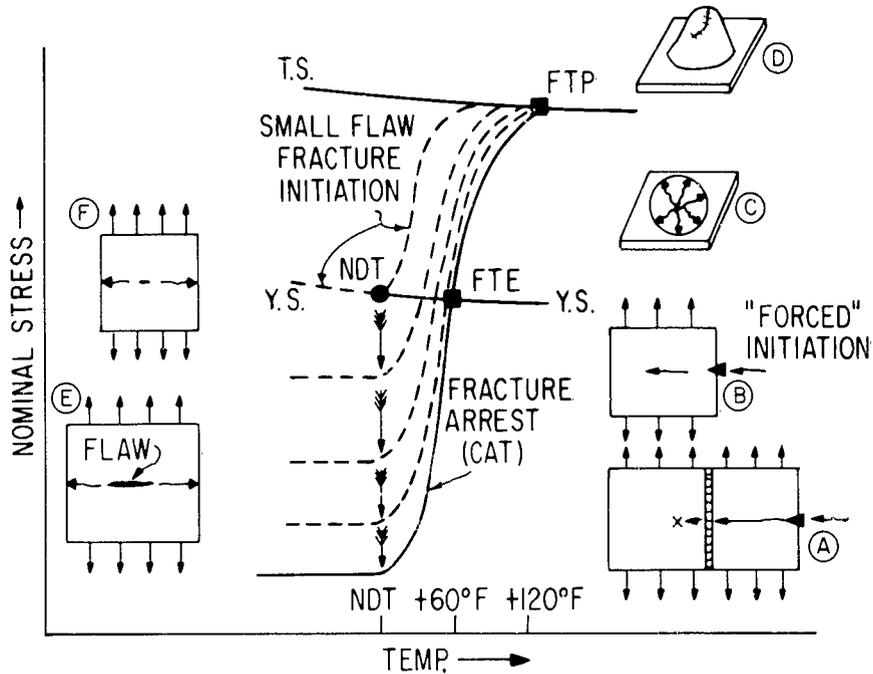
Fig. 2 — Features of large-scale fracture initiation and fracture arrest tests

The various types of tests which have provided data required to chart this diagram are illustrated in Fig. 2. Crack arrest tests may be conducted with a composite plate comprising a brittle plate welded to a "test" plate, sketch (A). After the assembly is brought to a specific temperature and stress level, "forced" initiation of a fracture in the brittle plate by wedge impact is used to develop a rapidly running brittle fracture. The fracture continues through the "test" steel or stops, depending on whether the temperature is below or above the CAT for the steel at the specific stress level of the test. A series of tests are conducted to establish the boundary of the "run" and "stop" temperatures. Variations of this test include wedge impact starting of a fracture in

the test plate itself, sketch (B), or in a prolongation of the test plate, which is cooled to low temperatures. Data on crack arrest properties at stresses and temperatures above the FTE point have been obtained primarily by the use of crack-starter explosion tests, sketches (C) and (D), to be explained. FTP performance in this test is indicated by the development of a deep hemispherical bulge with fractures restricted to short, shear tears, sketch (D).

Large-scale, fracture initiation tests have been conducted by introducing flaws (fatigue cracks, brittle weld cracks, etc.) of various dimensions in a test plate and loading to establish the fracture stress, sketches (E) and (F). Figures 1 and 2 illustrate that the family of dashed curves representing the fracture initiation stress for various flaw sizes are bounded or "cut off" by the CAT curve. This curve begins to rise sharply at the NDT temperature with a slope such that the CAT for yield stress loading (FTE) is reached at $NDT + 60^\circ F$ and FTP properties are reached at $NDT + 120^\circ F$.

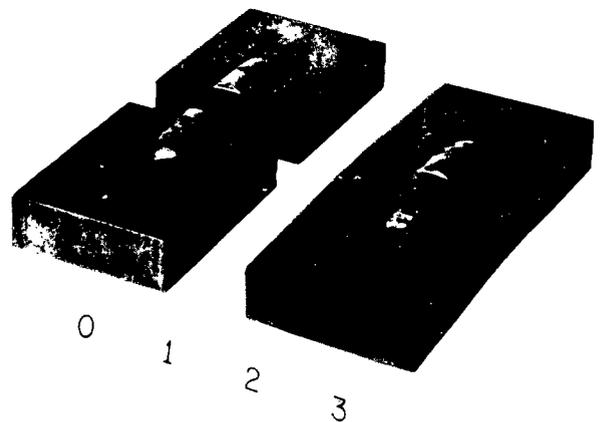
Fig. 3 — Drop-weight test specimen ($2 \times 5 \times 5/8$ in.) before test (right) and after test at, or below, the NDT temperature (left), illustrating the function of the brittle weld as a "crack starter" flaw

The importance of the NDT temperature as a *reference point for the generalized diagram* resides in the fact that it may be determined easily by the use of the drop-weight test. Figure 3 illustrates a drop-weight test specimen before and after test below the NDT temperature. The drop-weight test features the use of a brittle weld bead which cracks on "bend" loading to the yield point of the test plate surface. The resulting brittle crack represents the starting flaw or notch. The size of this

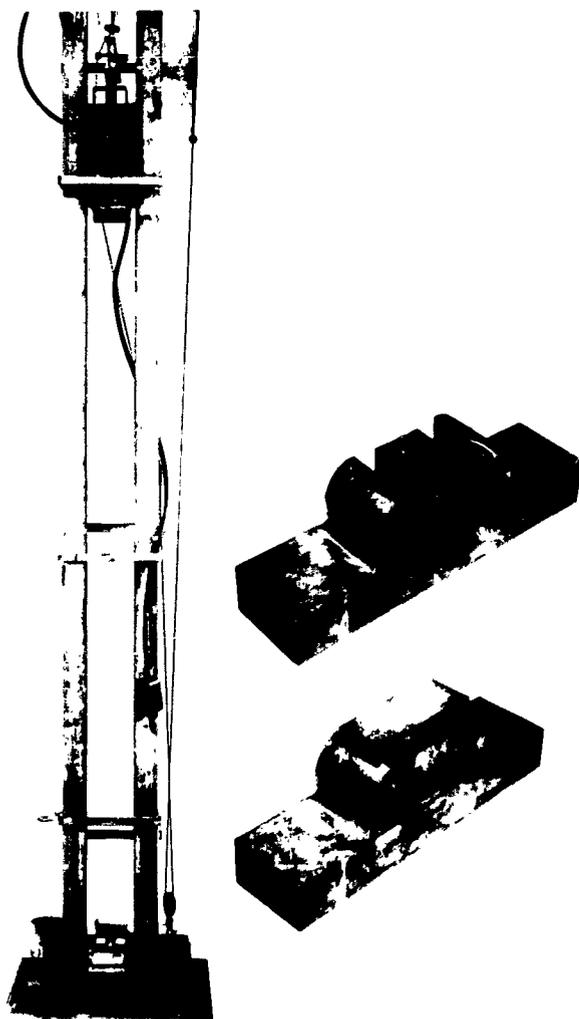
Fig. 4 — Drop-weight test equipment (left); details of anvil for 2x5x5/8 in. specimens (right)

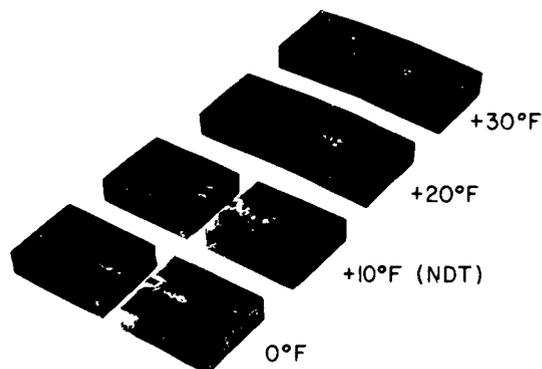
Fig. 5 — Typical drop-weight test series, illustrating an NDT at 10°F

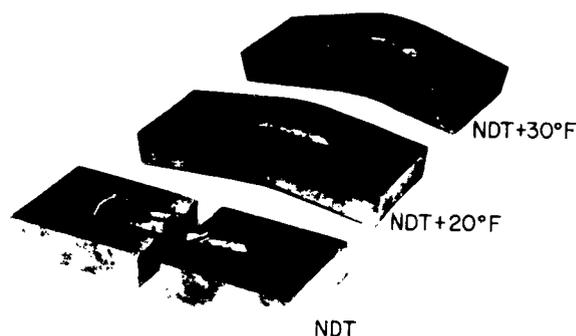
Fig. 6 — Open anvil test series illustrating bend deformation (ductility) developed at temperatures above the NDT temperature as compared to the “flat break” at and below the NDT temperature

Figure 6 documents the high resistance to fracture initiation exhibited by the same steel shown in Fig. 5 for tests at temperatures above the NDT, with a special demonstration series featuring an open span (no stop). Unlike most laboratory fracture tests which tend to develop data scatter, the drop-weight test is highly reproducible. Another feature of the test is that it is insensitive to orientation with respect to rolling or

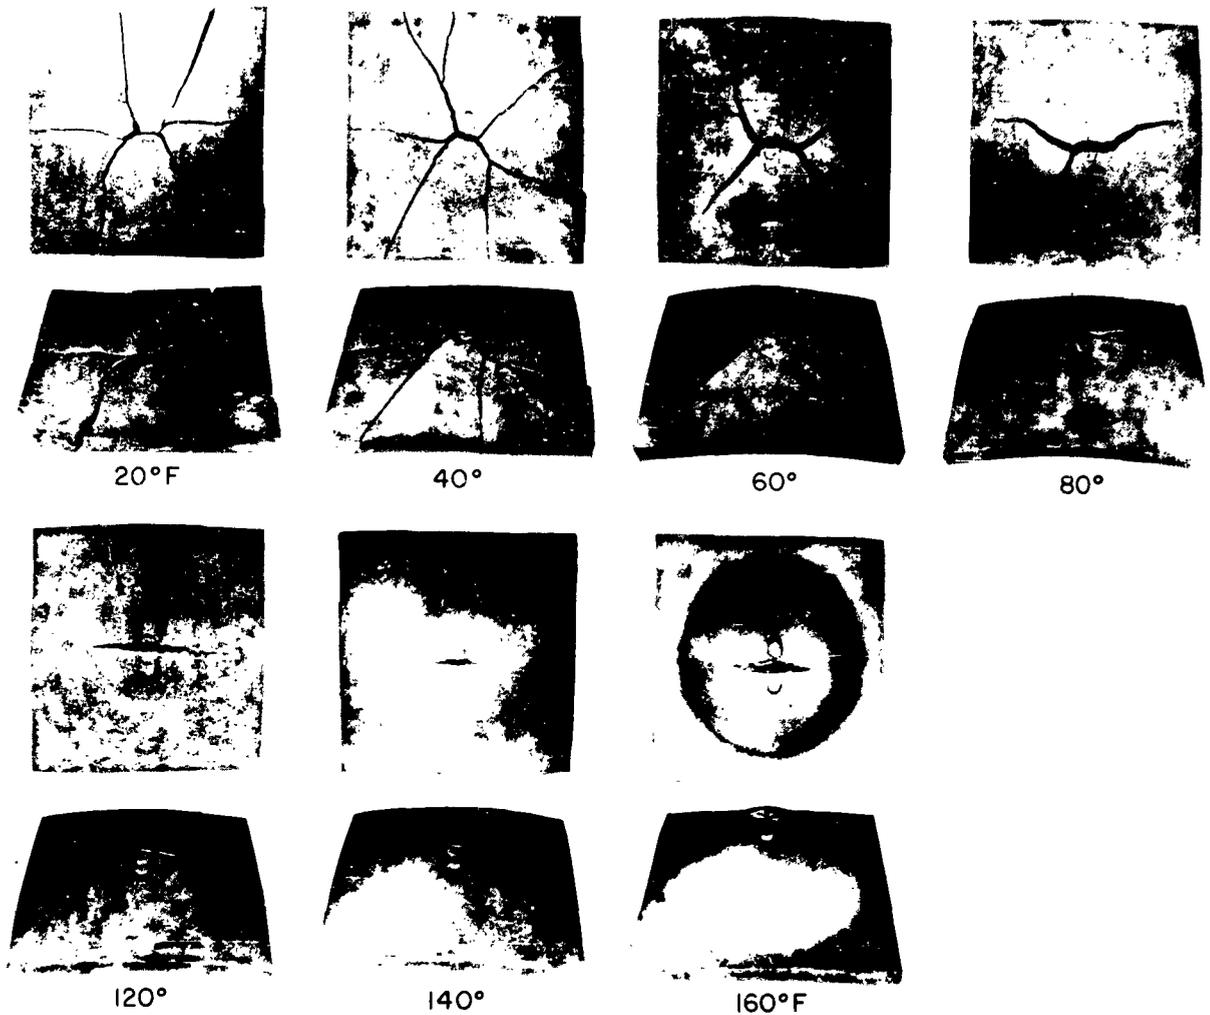
Fig. 7 — Explosion crack-starter test series in 20°F steps illustrating the dramatic increase in fracture toughness of steels above the NDT temperature (for the steel shown, NDT = 20°F, FTE = 70°F, and FTP = 140°F)

Figure 7 presents a panoramic view of the dramatic temperature effect in 20°F steps, for a World War II ship plate steel test series. At and below the NDT temperature, 20°F for this steel, the test plates break “flat.” Above the NDT temperature the plates *bulge* before fracture, indicating difficult (plastic strain required) starting of the fracture. In conformance with the plastic strain-temperature relationships of the small flaw fracture initiation curve at temperatures above the NDT temperature, the level of pre-fracture bulging (plastic stress levels) increases continuously with increasing temperature in the NDT to FTP range. The fractures, once started, run through the “hold down” regions of the bulge (elastically loaded die supported regions) at all temperatures below the FTE. At temperatures above the FTE, the fractures are entirely contained in the

plastic loaded regions of the bulge (short fractures). Above the FTP temperature only short, ductile tears are developed, even with the intentional forcing of deformation to a complete hemisphere, as shown by the 160°F test plate of the series. The FTP temperature is approximately 120°F above the NDT temperature. These results have been confirmed for a wide variety of steels and for plates up to 3 in. in thickness.

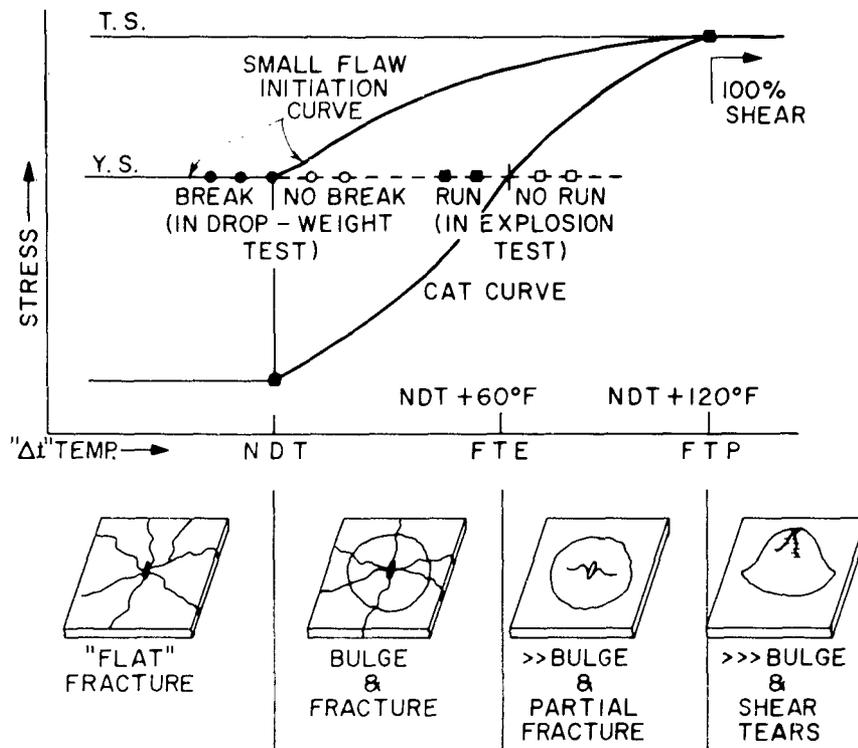
Fig. 8 — Drop-weight and explosion crack-starter test series related to the generalized fracture diagram

By reference to Fig. 8, we may now relate drop-weight and explosion test performance to the fracture analysis diagram, as follows:

1. Nil ductility (fracture of drop-weight specimens and flat break in explosion tests) occurs at and below the NDT temperatures.

3. Above the FTE temperature, fractures do not run through the elastic load or "hold down" regions, thus indicating the CAT for yield stress loading has been exceeded.

4. Propagation of partially brittle fractures through the plastically deformed center regions of bulge are developed in the range between the FTE and FTP temperatures.

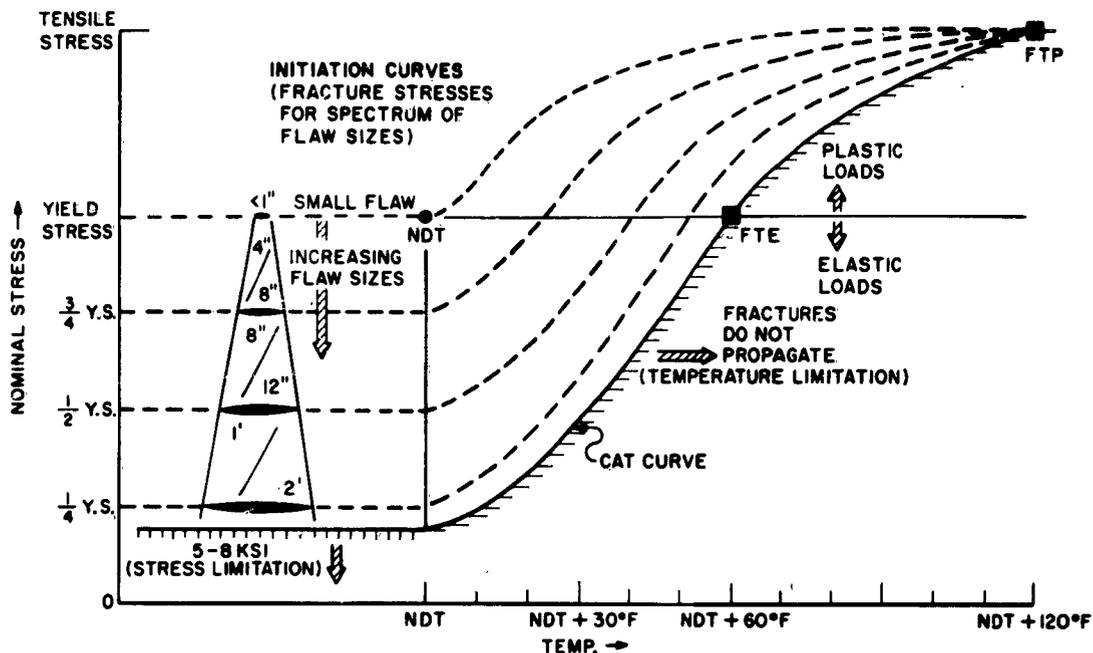
Fig. 9 — Generalized fracture analysis diagram, as referenced by the NDT temperature

The approximate range of flaw sizes required for fracture initiation at various levels of nominal stress are illustrated by the generalized fracture analysis diagram of Fig. 9. The flaw size data have been derived from a wide variety of small flaw tests, from limited studies of tensile tests with large flaws introduced into 1 in. and 3/4 in. thick plates, and from theoretical fracture mechanics concepts developed by G. R. Irwin (3). Validation is provided by a large amount of failure and structural test data, to be presented. The generalized diagram presents a family of fracture initiation curves relating to a range

of flaw sizes. These range from flaws of less than 1 in. (top dashed curve) to flaws in the order of 1 to 2 ft (bottom dashed curve). It should be noted that all initiation curves have been drawn to show a rapidly increasing requirement for higher stresses with increasing temperature above the NDT temperature. The actual slope and shape of the "rising" portions of the initiation curves represent estimates based on the general slope of the crack arrest curve.

The diagram predicts that for a given level of stress, larger flaw sizes will be required for fracture initiation above the NDT temperature. For example, at stresses in the order of 3/4 Y.S., a flaw in the order of 8 to 10 in. may be sufficient to initiate fracture below the NDT temperature; however, at NDT + 30°F, a flaw of 1-1/2 to 2 times this size may be required for initiation. To the right of the CAT, there is "no flaw" that is of sufficient size to initiate fracture because propagation of brittle fractures is not possible. It should be noted that the nominal stress plotted in this diagram is the stress acting on the volume of material within which the flaw resides. Thus, for a flaw residing in the shell region of a pressure vessel, the nominal stress is the shell stress vector component; for a flaw residing at a nozzle the nominal stress is the higher level of stress acting at that particular position in the nozzle.

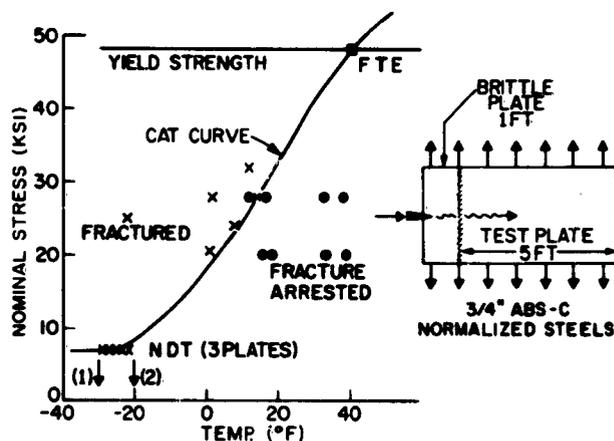
Fig. 10 — Correlation of CAT data obtained by Mosborg (4) with NDT temperatures of the test steels. The data relate to three separate plates from one heat.

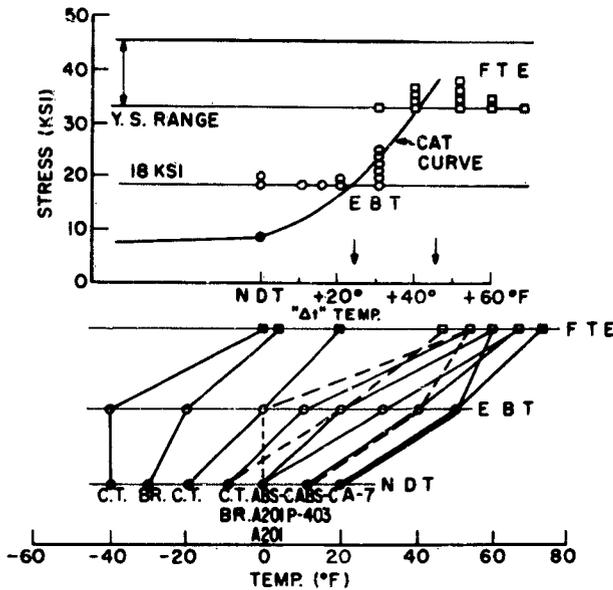
Fig. 11 - The lower graph illustrates the temperatures determined for the NDT, EBT, and FTE for 12 steels; the data relating to each steel are connected by a reference line. The "Δt" relationships of the EBT and the FTE to the NDT temperature are summarized in the upper graph. The crack arrest curve drawn in the top graph represents the "mean position" CAT curve indicated by the "Δt" data points.

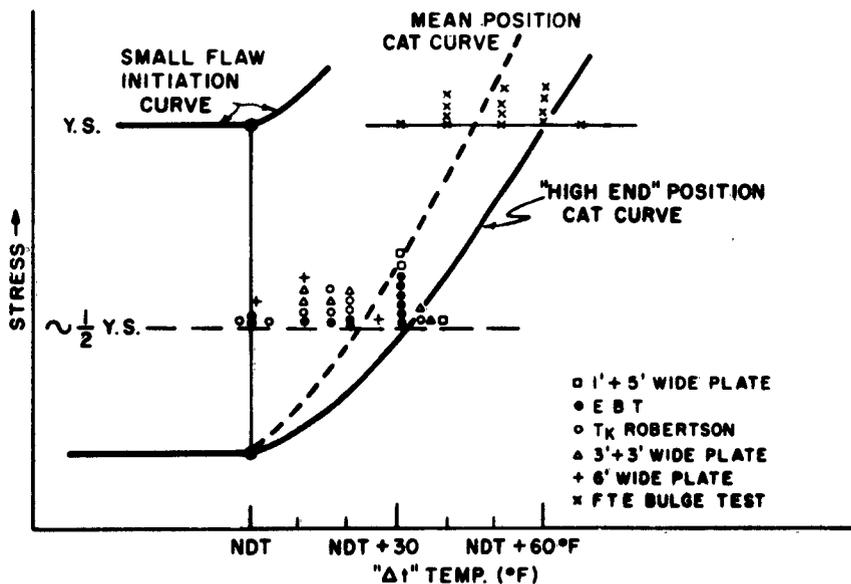
Fig. 12 - Summarization of "Δt" CAT data for 32 steels, representing a wide variety of tests conducted at stress levels of approximately 1/2 the yield strength level of the various steels. A total of 14 steels were also tested by the explosion crack starter test to establish the "Δt" FTE (CAT for Y.S. level). These data represent the bases for the fracture analysis diagram location of the CAT curve referenced to the NDT point.

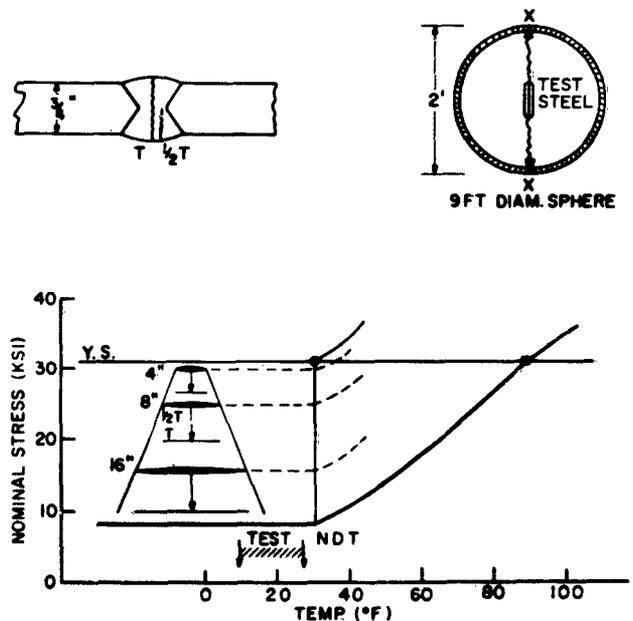
Fig. 13 - Summary of hydrostatic test shell stresses required for the initiation of fracture for flaws of 4, 8, and 16 in. dimensions. All tests were conducted at temperatures ranging from 5° to 20°F below the NDT temperature of the test steel, a 3/4-in.-thick ship plate.

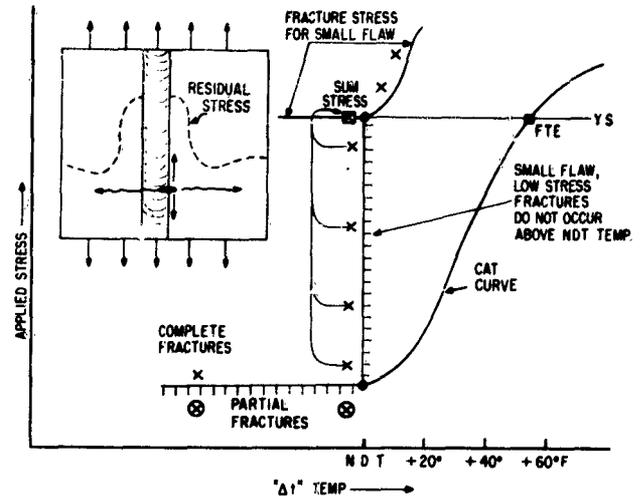
Fig. 14 — Illustrating the fracture analysis diagram prediction that the NDT represents the highest temperature for the initiation of "low-stress" fractures in the presence of high residual stress fields. Complete fractures are predicted for conditions such that the applied stress level exceeds 5 to 8 ksi; short fractures result if the applied stress level is less than this value.

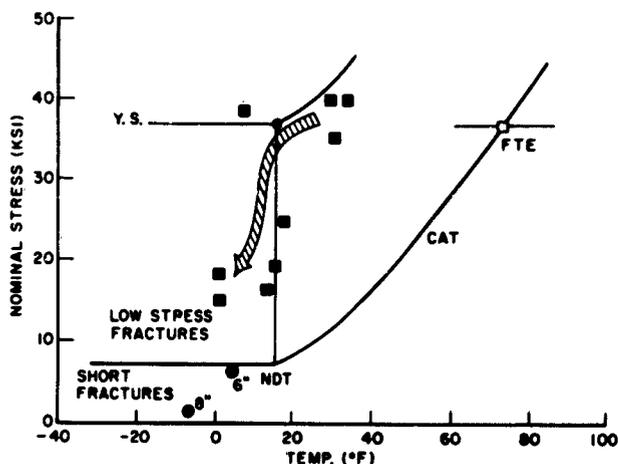
Fig. 15 - Wells (8) data points which define the critical edge temperature for low-stress fracture superimposed on the fracture analysis diagram of the test steel: 1-in. plate, 0.14% C, 1.07% Mn, 0.02% Si.

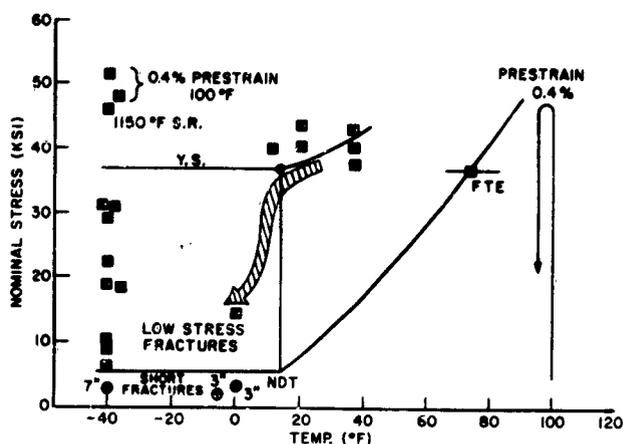
Fig. 16 - Hall, Nordell, and Munse (9) data points which define the critical edge temperature for low-stress fracture superimposed on the fracture analysis diagram for the test steel: 1-in. plate, ASTM A212-B, 0.30% C, 0.76% Mn, 0.26% Si.

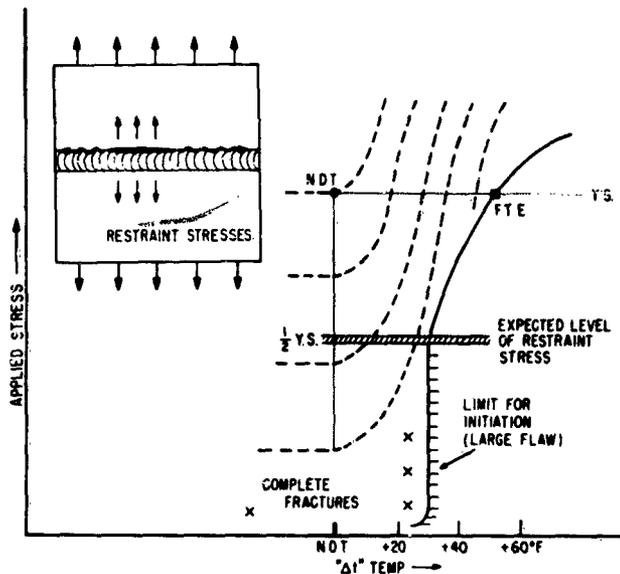
Fig. 17 - Illustrating the fracture analysis diagram prediction that large flaws located in restraint stress fields (of $1/2$ the yield strength) may result in low-stress fracture initiation at temperatures below the CAT ($NDT + 30^\circ F$)

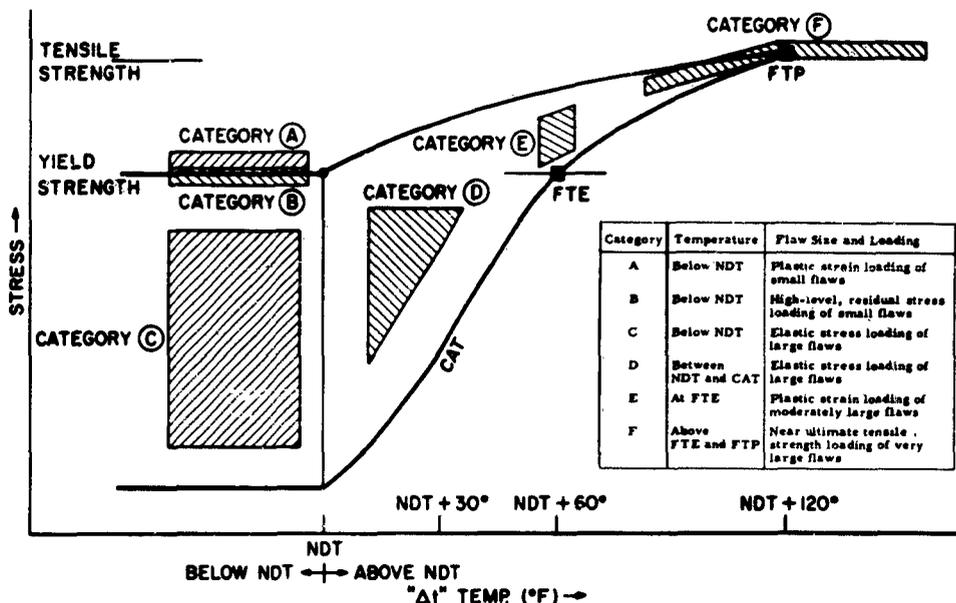
Fig. 18 — Sequence of the discussion of failure-analysis cases is indicated by categories A to F referenced to various zones of the fracture analysis diagram

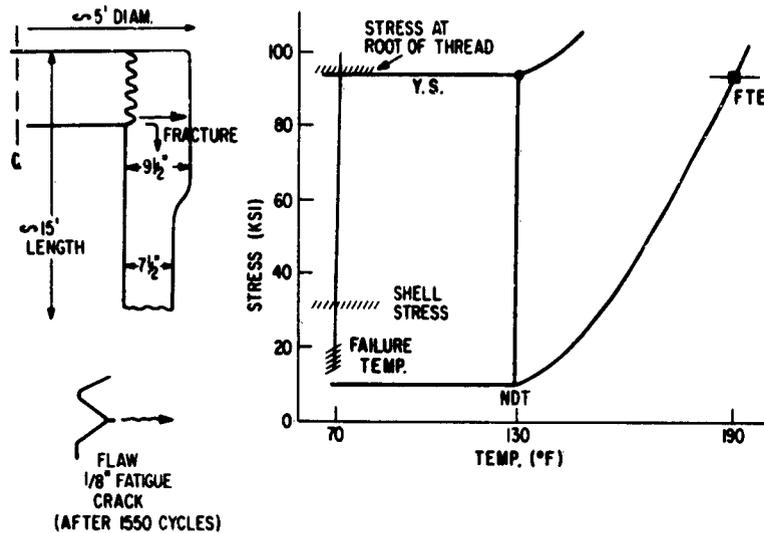
Fig. 21 - (Case A1) Fracture analysis relating to the service failure of the 100-ton, forged, ASTM A293 pressure vessel

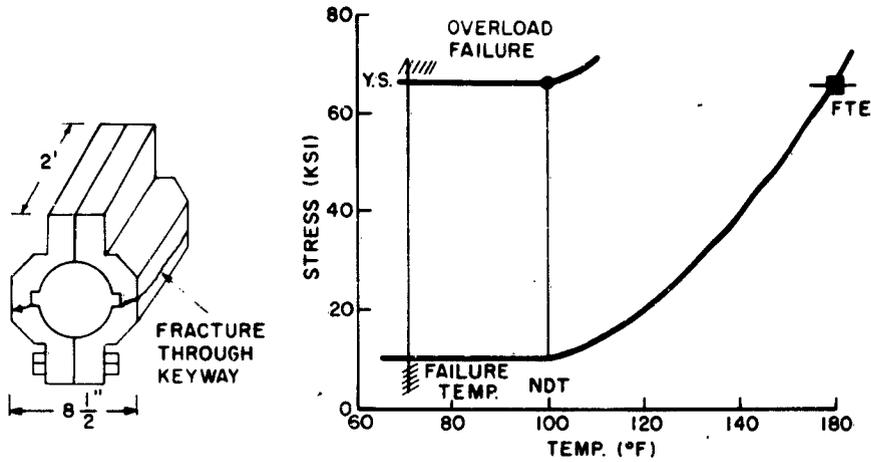
Fig. 23 - (Case A2) Fracture analysis relating to the overload failure of the forged, SAE 1050, anchor windlass-shaft coupling

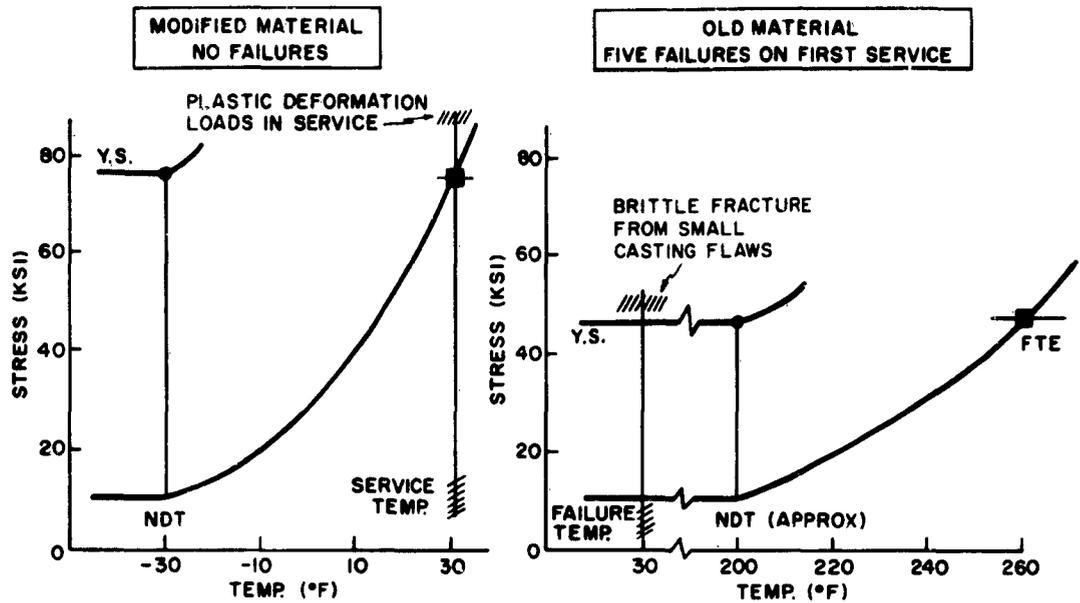
Fig. 25 - (Cases A3 to A7) Fracture analysis relating to the overload failures of cast 12% chromium stainless steel propellers (right); note that the service temperature was below the NDT temperature. Improvement in the steels resulted in shifting the NDT temperature to 60°F below the service temperature. For the improved propeller steels, the fracture analysis diagram (left) predictions for safe performance under overload conditions were justified.

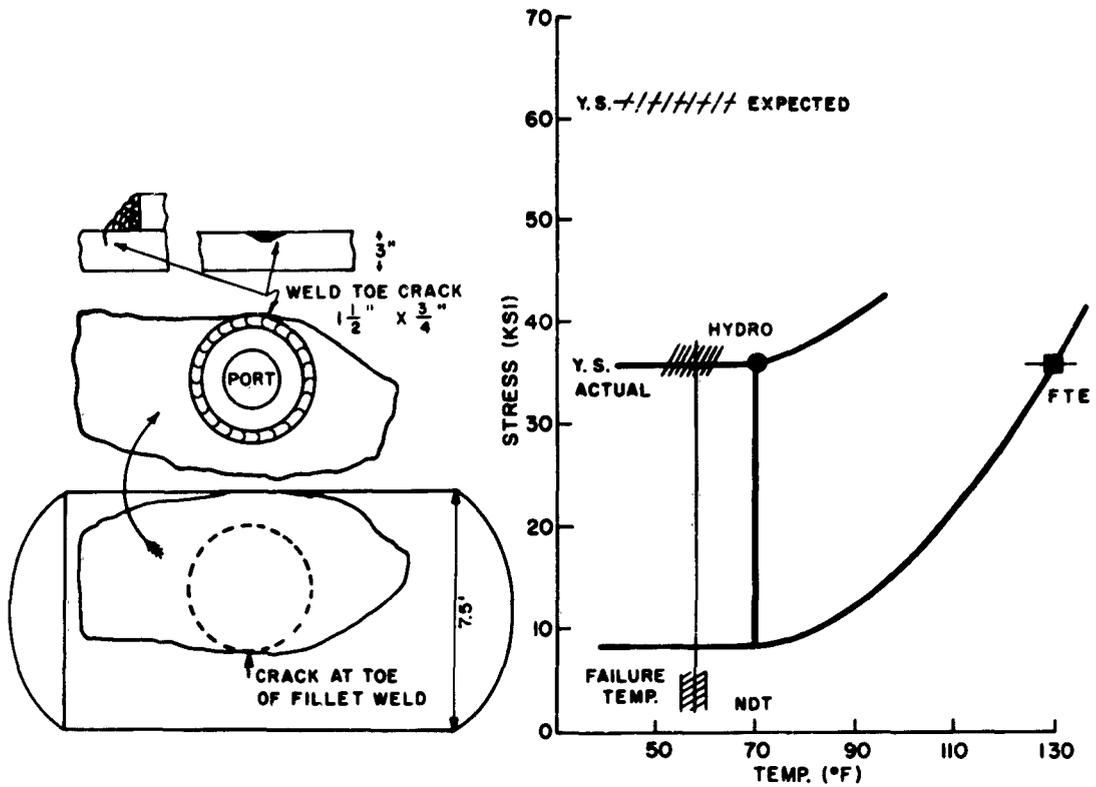
Fig. 27 - (Case A8) Fracture analysis relating to the hydrotest failure of the stress relieved ASTM A302-B pressure vessel. The steel was given an annealing heat treatment by error which resulted in hydrotest shell stresses equal to the yield strength level.

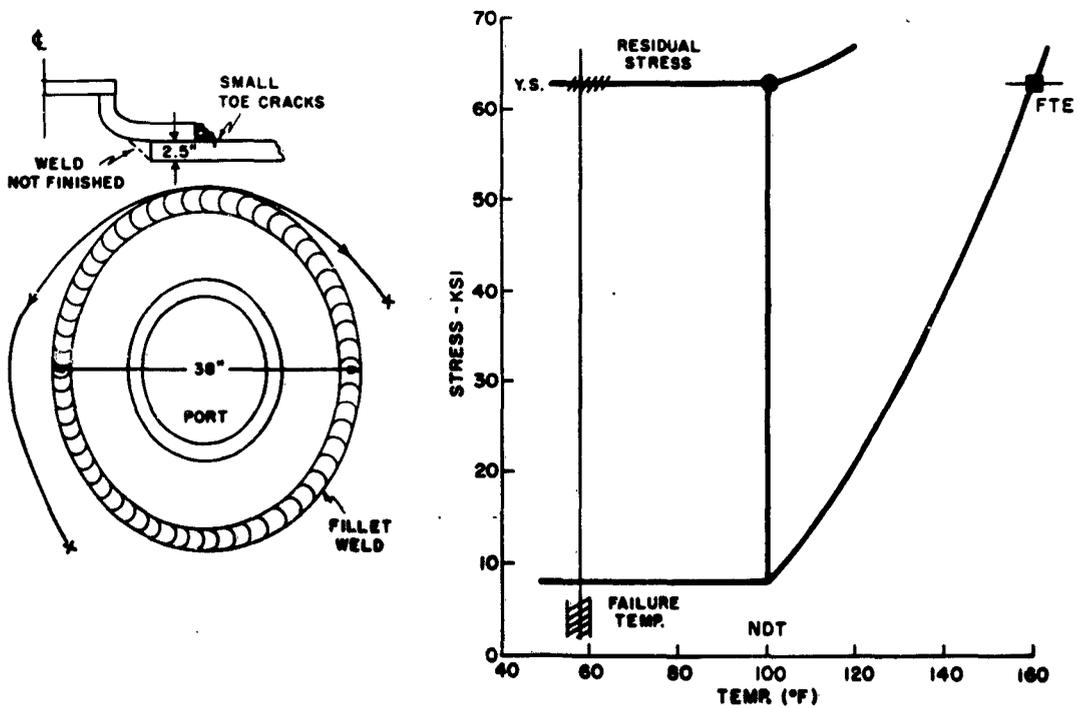
Fig. 28 - (Case B1) Fracture analysis relating to the spontaneous fracture of a partially fabricated ASTM A302-B pressure vessel

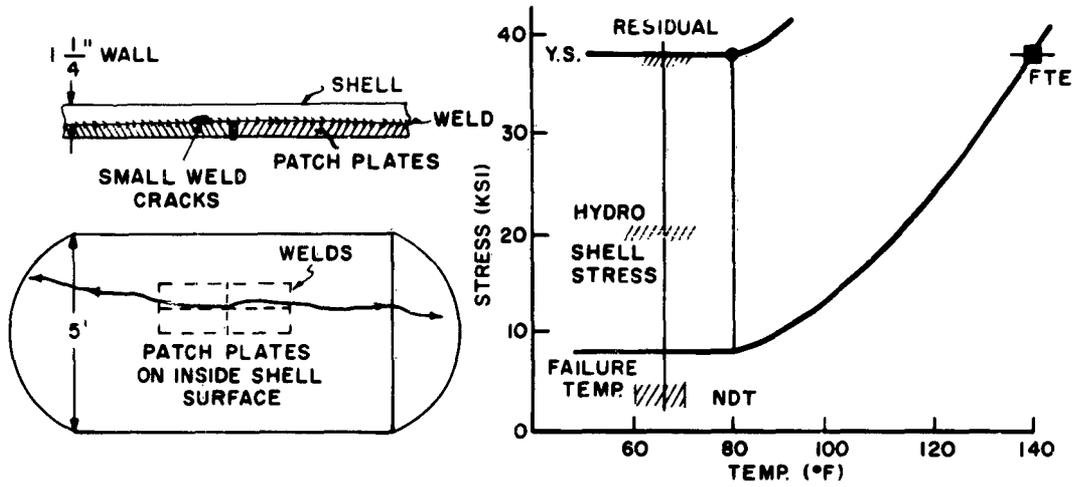
Fig. 30 - (Case B2) Fracture analysis relating to hydrotest failure of the patch-plate-repaired ASTM-A212-B pressure vessel. The vessel was not stress relieved after completion of the weld repairs.

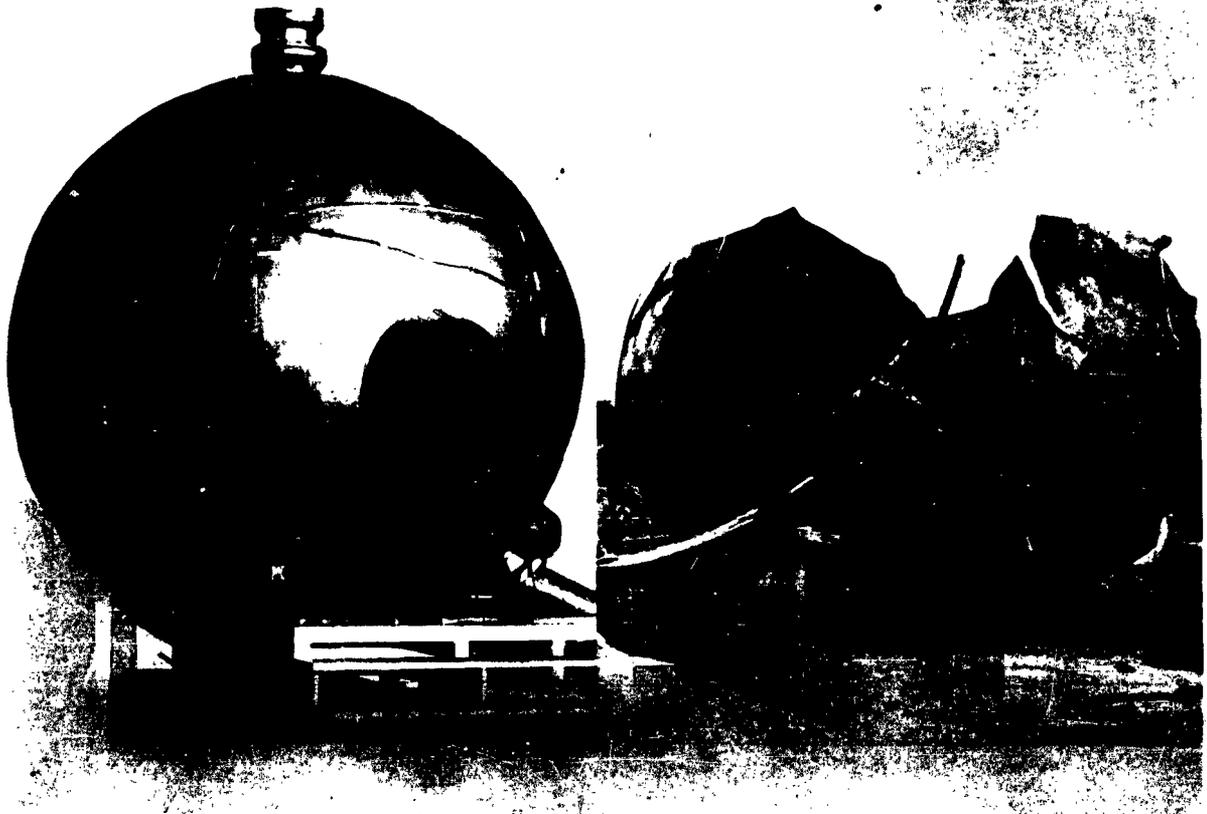
Fig. 31 - (Case B3) Blast chamber prior to fracture (left) and after fracture (right)

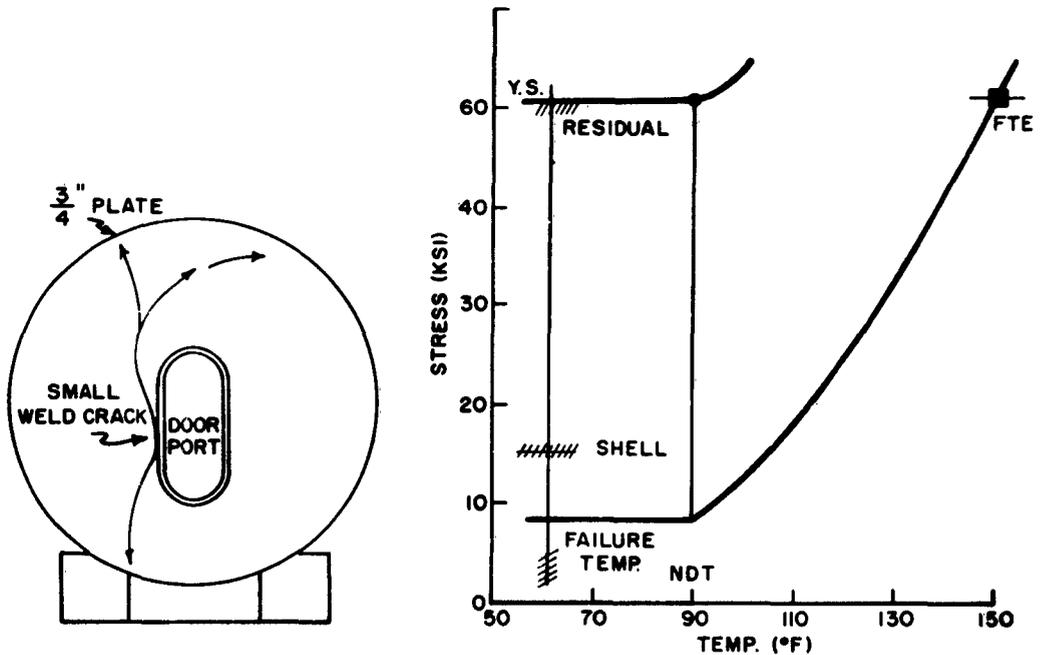
**Fig. 32 - (Case B3) Fracture analysis relating to service failure of the ASTM A285-C blast chamber.
The vessel was not stress relieved.**

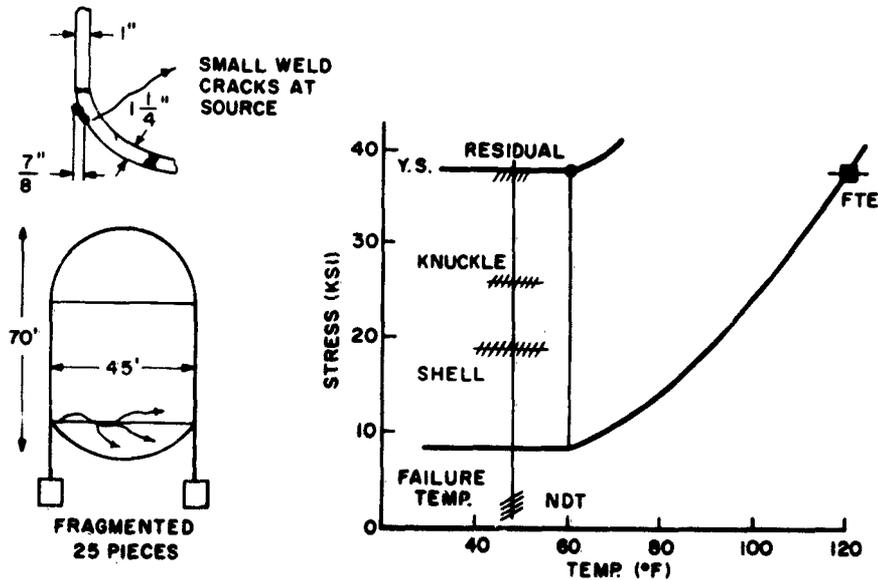
Fig. 33 - (Case B4) Fracture analysis relating to hydrotest failure of a 45-ft-diameter ASTM A285-C storage tank. The vessel was not stress relieved.

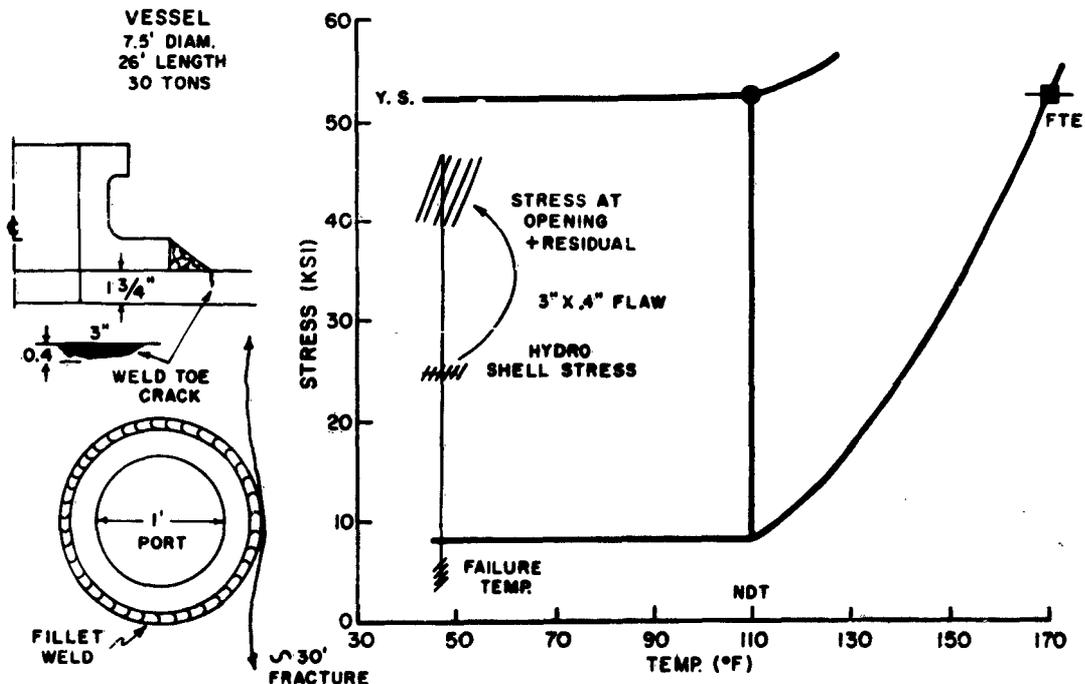
Fig. 36 - (Case B5) Fracture analysis relating to the hydrostatic test failure of the CO converter pressure vessel. The data relate to the ASTM A204 portion, which was the initiation point. The vessel was given an inadequate stress relief at 950°F.

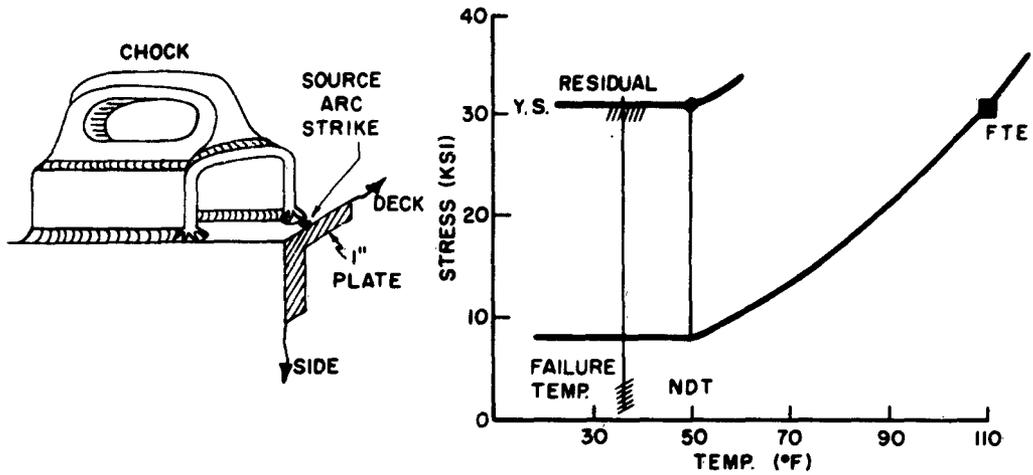
Fig. 38 - (Case B6) Fracture analysis relating to the dockside failure of the T-2 tanker Ponaganset

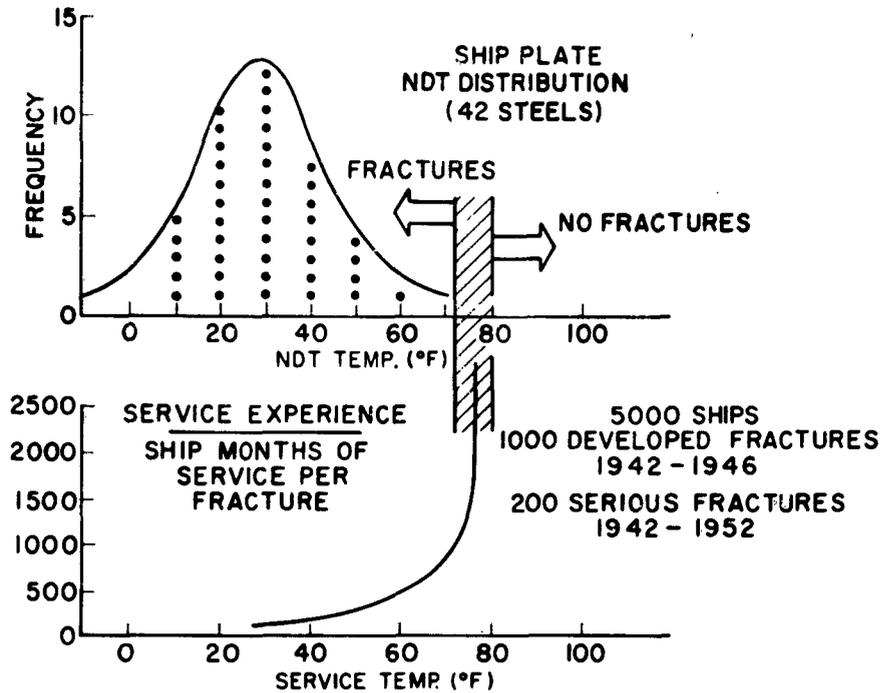
Fig. 40 - Illustrating that no failures of World War II ships occurred at temperatures above the 70°F upper limit of the NDT frequency distribution range of World War II ship steels. A high rate of fracture per month of service occurred at temperatures of 30° to 50°F, for which 20 to 50% of the steels were below their NDT temperatures.

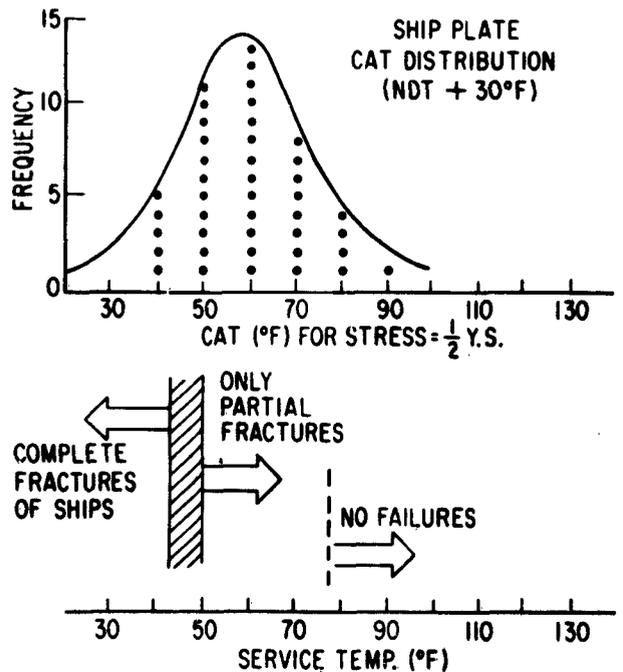
Fig. 41 - Illustrating that complete failure of ships occurred only at temperatures such that essentially all of the ship steels were below their respective CAT

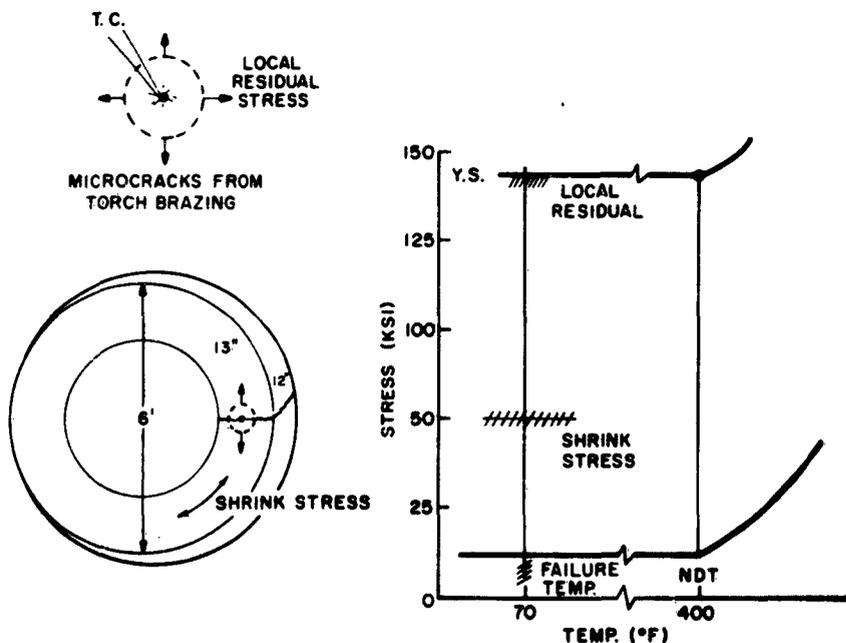
Fig. 44 - (Case B7) Fracture analysis relating to the spontaneous fracture of the ASTM A293 retaining ring forging

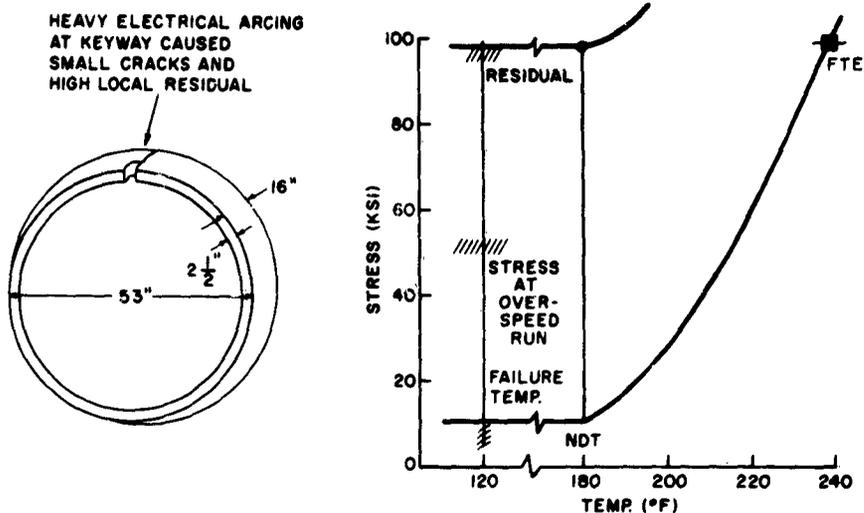
Fig. 46 — (Case B8) Fracture analysis relating to the overspeed run failure of the SAE 3335 retaining ring forging. Data by Greenberg (12).

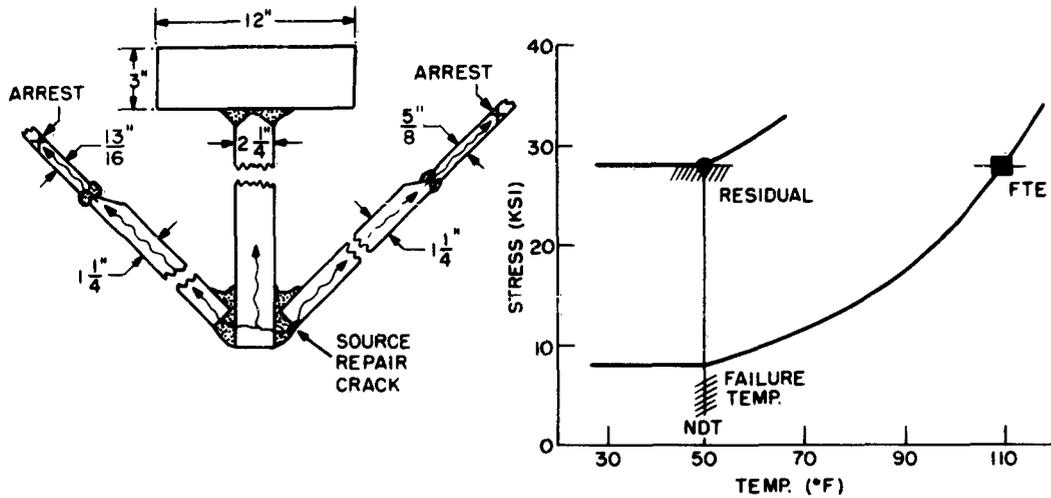
Fig. 48 - (Case B9) Fracture analysis relating to the hydrotest failure of the power dam outlet pipe manifold

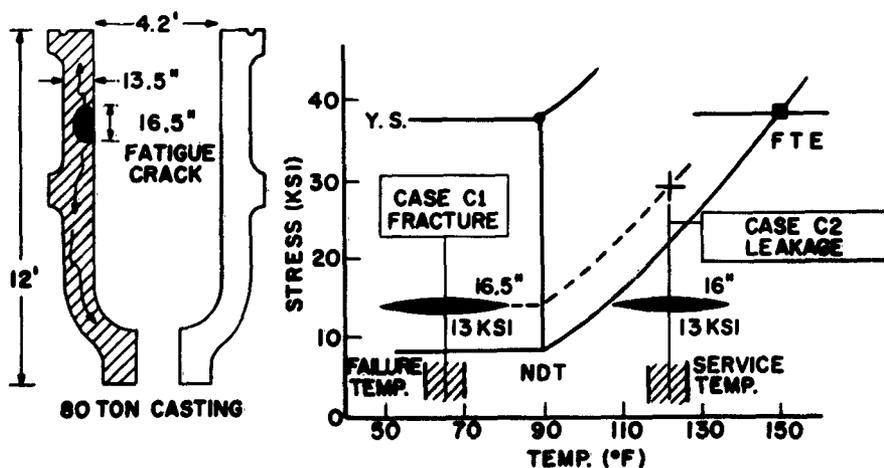
Fig. 49 – (Case C1) Fracture analysis relating to the service failure below the NDT of an ASTM A27 cast-steel extrusion press cylinder. (Case C2) Fracture analysis relating to leakage failure above the CAT of a similar cylinder for a smaller press operating at a higher service temperature.
